THE AUSTIN HEALEY CLUB OF AMERICA, INC.

February 1993

How to Rebuild a Healey - in Thirty Easy Lessons

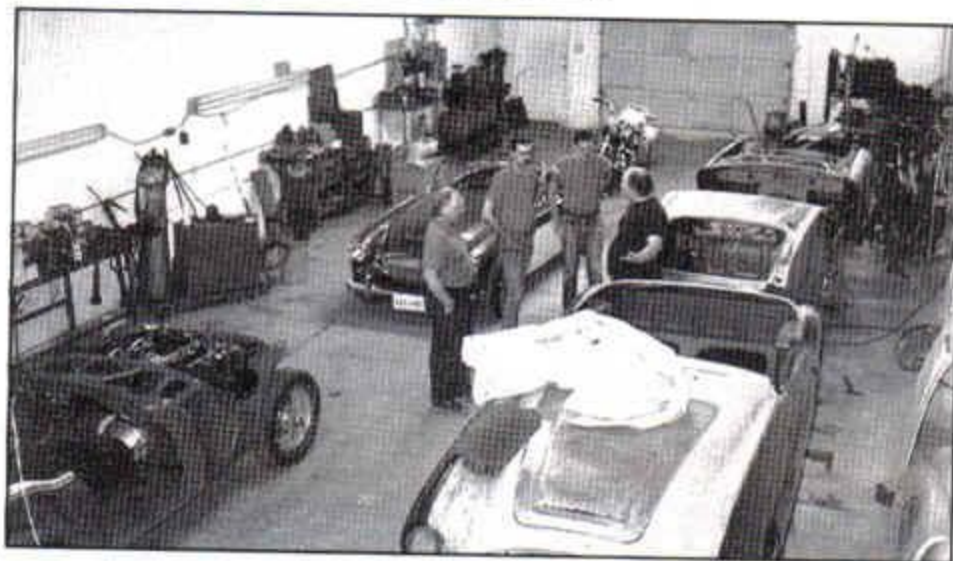
All the students were surprised at the condition of the old chassis. There were stress cracks at the engine mount towers. One main rail was broken through at the firewall and lace thin toward the engine compartment. The two main rails were approximately two inches closer to each other than when it left the factory. They certainly had acquired lots of distortion over the years. On the class car we would be using a Jule chassis. But before we got to that point there was a lot of discussion about the pros and cons of a replacement chassis. We all felt that Martin was very objective at this point and presented both sides of the story. As part of the discussion, we cut the old chassis in half on the good rail at a point where it seemed very solid. Contrary to what we had all been led to believe, it was very obvious that Healey chassis do rust from the inside out!

Top left: the frame was in bad shape with stress cracks and one of the rails rusted through. Above: Phil, Russ, Don and Martin stand between two cars that are under restoration while they discuss the next steps on the class car (bottom left).

Before we could start the repair it was time for another side lesson, this one on the use of the MIG welder. That under our belts the pieces of the new chassis were put into the jig and it was welded together. Once the chassis was out of the jig, the door sills were positioned and welded in place.

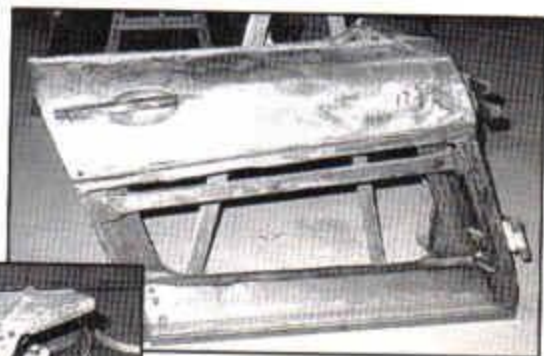
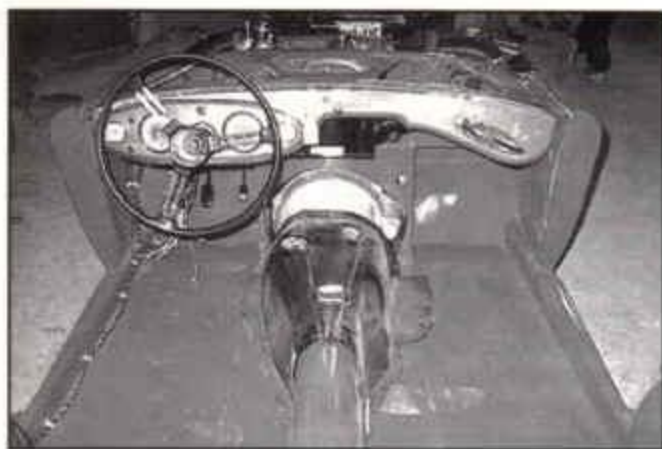
Far left: view of the primed substructure. Center left: many of the panels including the complete door pillar assembly were made and replaced. Above: the door panels were cut off just below the crease line and new panels manufactured the welded in place.

and bending. After the panels were made it was time to cut the old panels from the bulkheads and fit and weld in the new. New front door pillars were manufactured and the complete bulkhead corner replaced. It's unbelievable how many times those doors had to be taken on and off to get the front pillars fitted correctly.

sent out to a local shop that specializes in aluminum work. Our job was to repair the steel panels. This included hammering out some dents (we all need more practice on that skill!) plus manufacturing new skins to replace the rotten portions of the panels. The fender and door skins were cut off just below the crease line and the newly manufactured pieces welded into place. New rear door pillars and rocker panels were purchased and installed. Again, there was a lot of assembly and disassembly to ensure these were welded in the correct position. The shrouds and body panels were fitted with minor

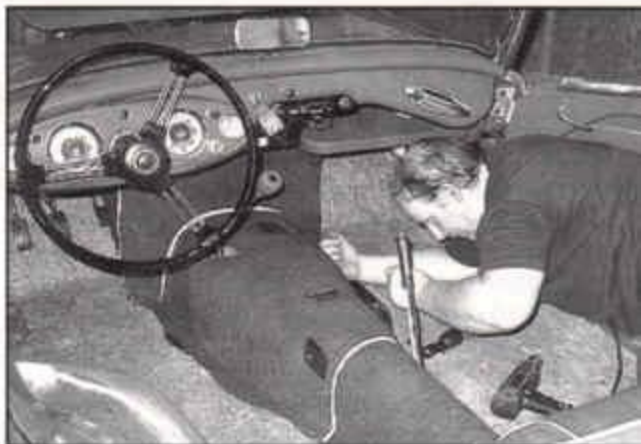
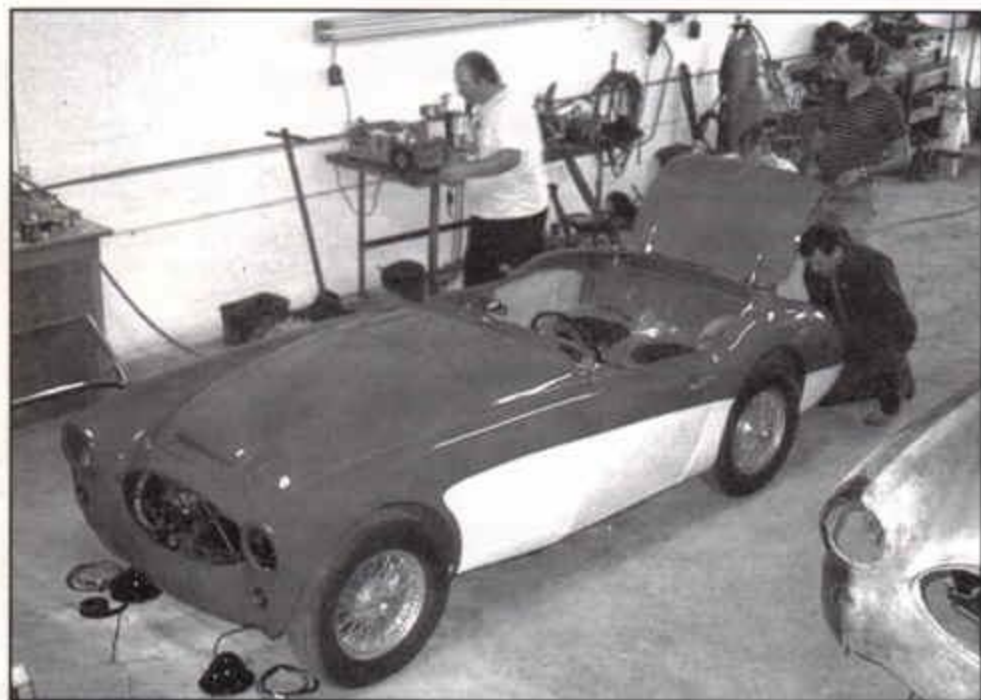
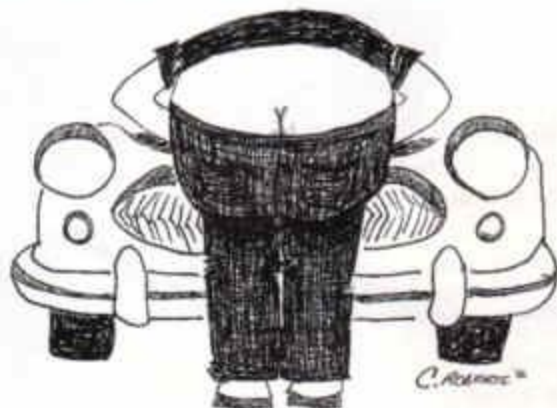
Above: new wiring harness was installed and all then connections made. Right: as we install the interior, Martin checks out some of our progress. Below: when we arrived the next Saturday morning we were all amazed at the car we had rebuilt!

The sub-structure and inner side of the panels were painted (not by the students). New brake lines, gas lines, and wiring harnesses were installed. Under the hood electrics, instrument panel, and suspension
