THE AUSTIN HEALEY CLUB OF AMERICA, INC.

February 1993

How to Rebuild a Healey - in Thirty Easy Lessons

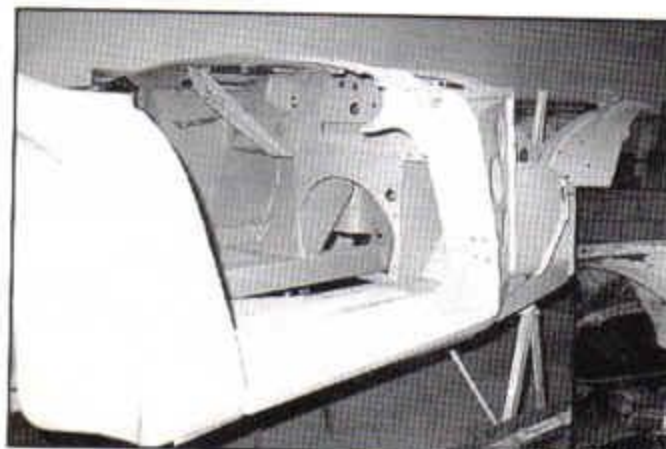
All the students were surprised at the condition of the old chassis. There were stress cracks at the engine mount towers. One main rail was broken through at the firewall and lace thin toward the engine compartment. The two main rails were approximately two inches closer to each other than when it left the factory. They certainly had acquired lots of distortion over the years. On the class car we would be using a Jule chassis. But before we got to that point there was a lot of discussion about the pros and cons of a replacement chassis. We all felt that Martin was very objective at this point and presented both sides of the story. As part of the discussion, we cut the old chassis in half on the good rail at a point where it seemed very solid. Contrary to what we had all been led to believe, it was very obvious that Healey chassis do rust from the inside out!

Top left: the frame was in bad shape with stress cracks and one of the rails rusted through. Above: Phil, Russ, Don and Martin stand between two cars that are under restoration while they discuss the next steps on the class car (bottom left).

Before we could start the repair it was time for another side lesson, this one on the use of the MIG welder. That under our belts the pieces of the new chassis were put into the jig and it was welded together. Once the chassis was out of the jig, the door sills were positioned and welded in place.

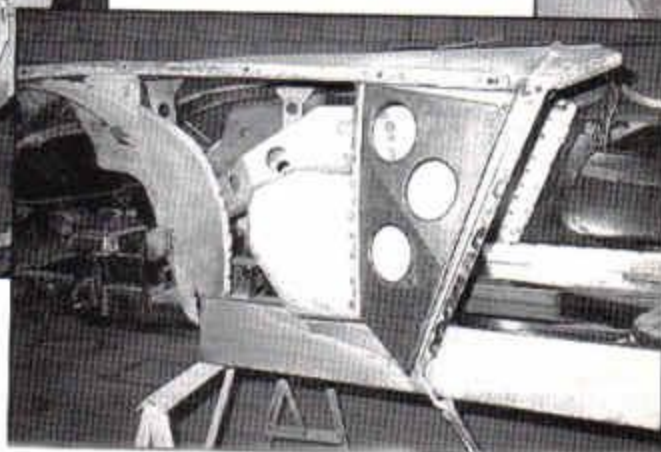
Far left: view of the primed substructure. Center left: many of the panels including the complete door pillar assembly were made and replaced. Above: the door panels were cut off just below the crease line and new panels manufactured the welded in place.

and bending. After the panels were made it was time to cut the old panels from the bulkheads and fit and weld in the new. New front door pillars were manufactured and the complete bulkhead corner replaced. It's unbelievable how many times those doors had to be taken on and off to get the front pillars fitted correctly.
